**Dam Safety Assessment of CCW
Impoundments**

**LG&E Mill Creek Station
Report**

October 2009

Dam Safety Assessment Report of CCW Impoundments LG&E Mill Creek Station

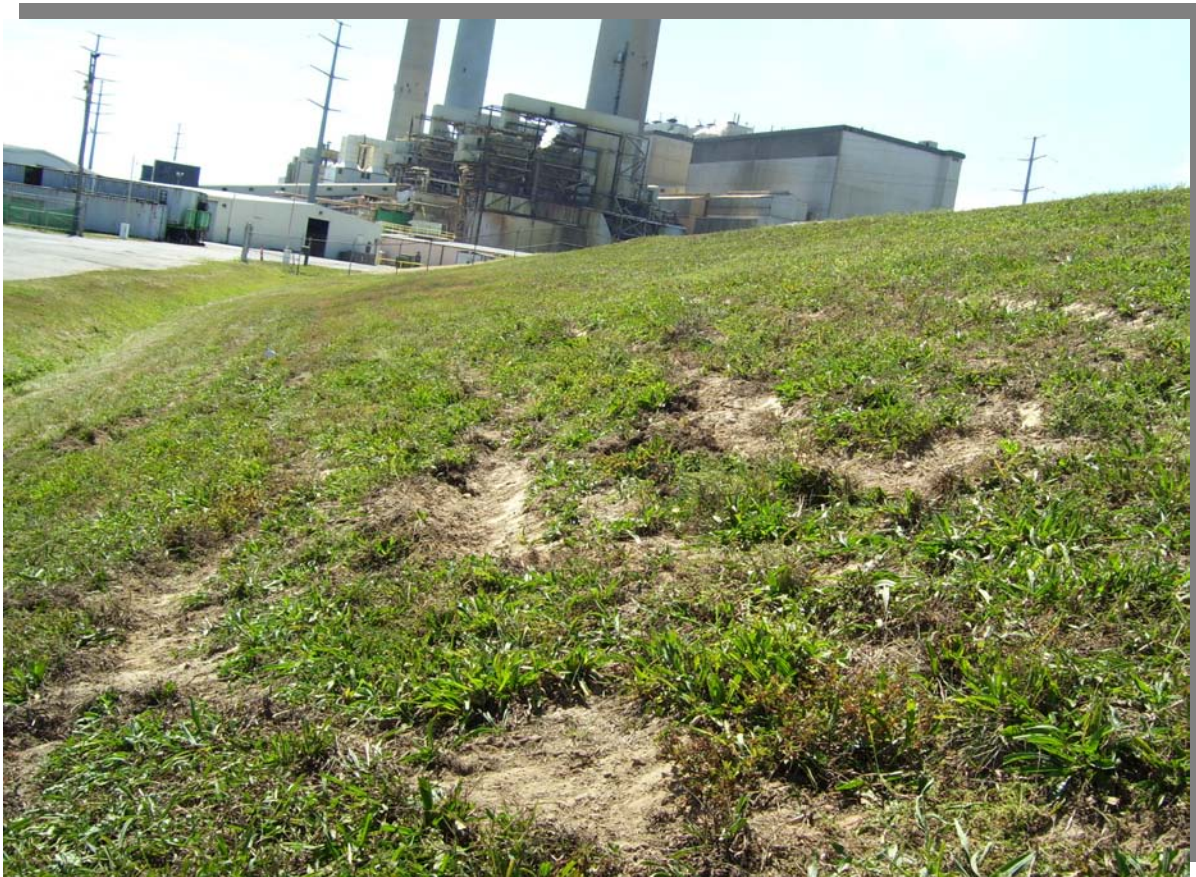
- The outboard slope of the east dike was vegetated with well maintained grass and appeared in good condition. Some minor isolated rutting by mowers was observed on the east outboard slope (Photo 1).

Photo 1 – View along eastern outboard slope looking south. Note rutting caused by mower/tractor.

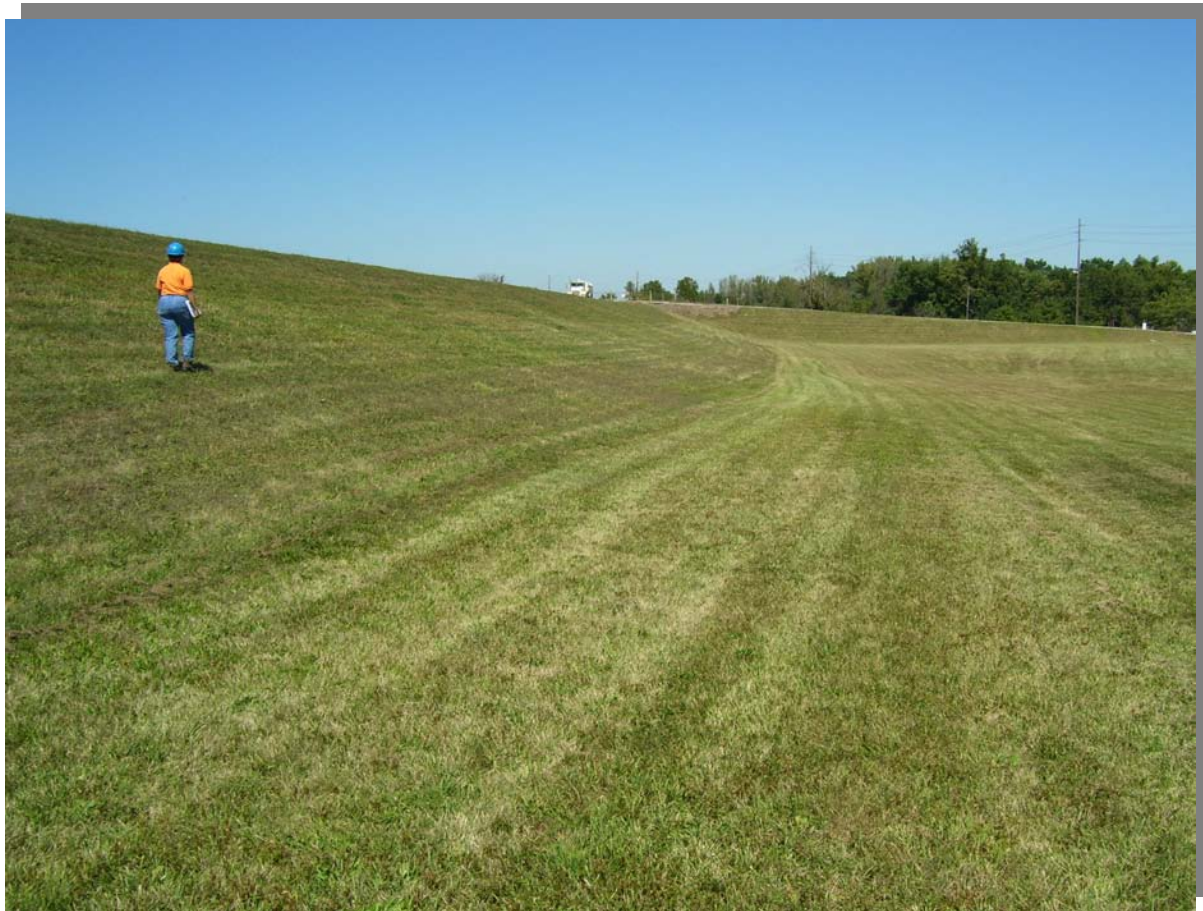
Photo 2 – View along 3H:1V eastern outboard slope looking north.

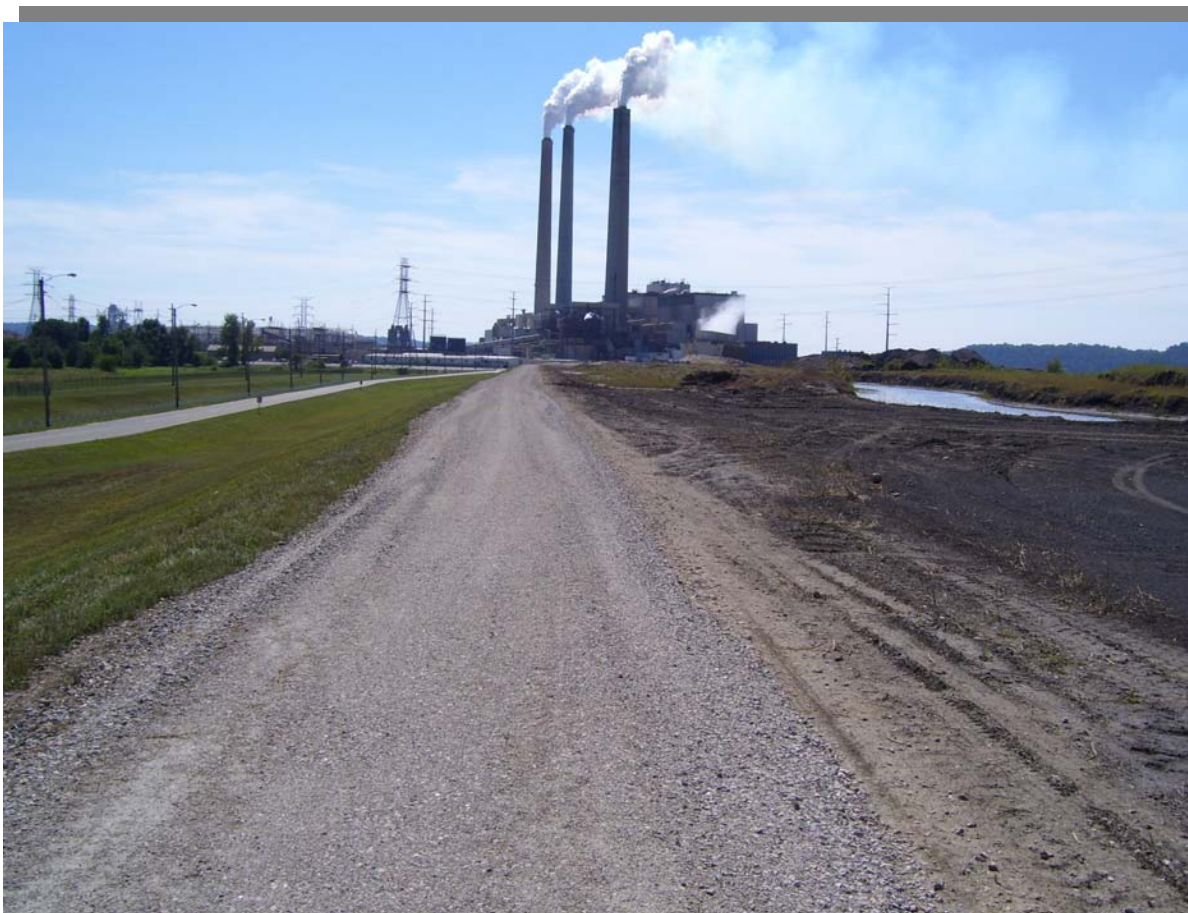
Photo 3 – View along crest of east dike looking south. Note ash deposits along right (west) side of crest.

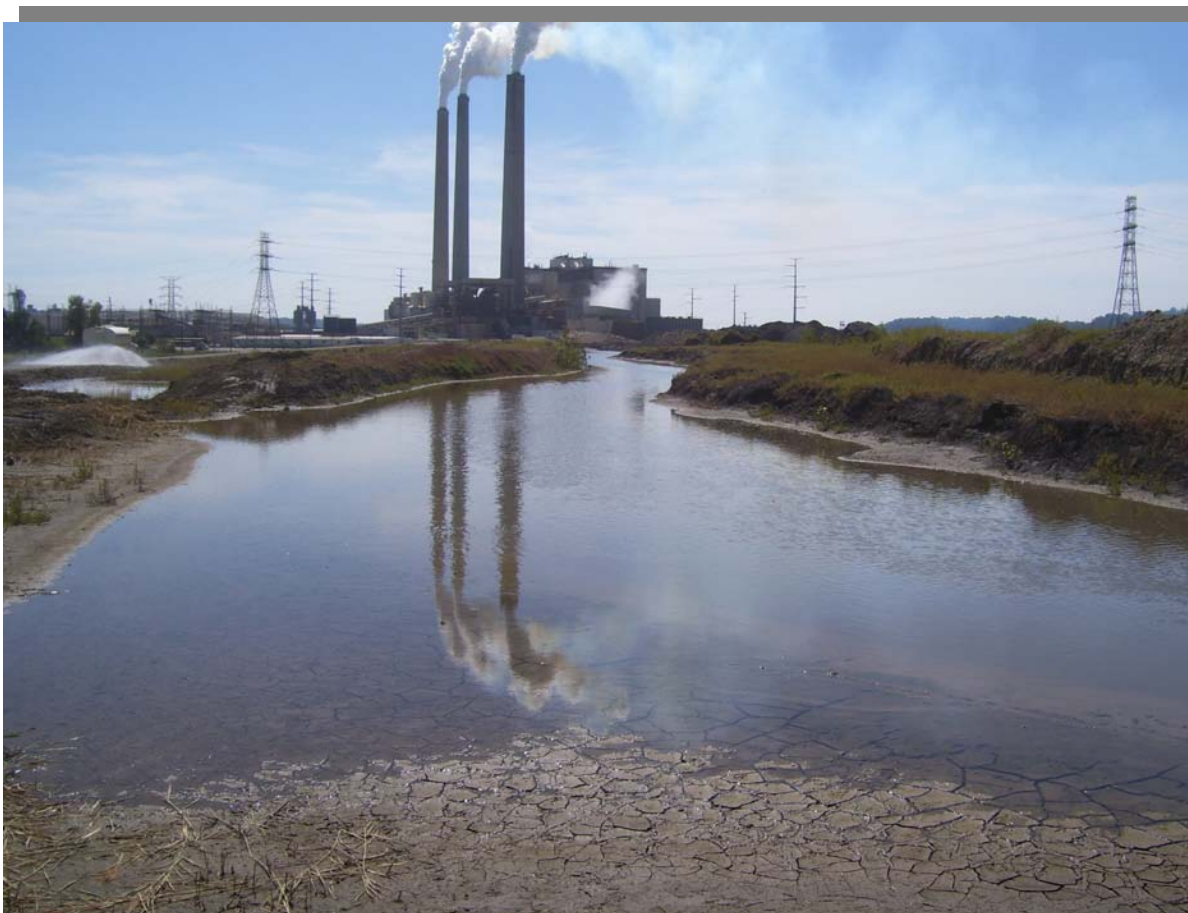
Photo 4 – View of influent channel looking southwest (upstream).

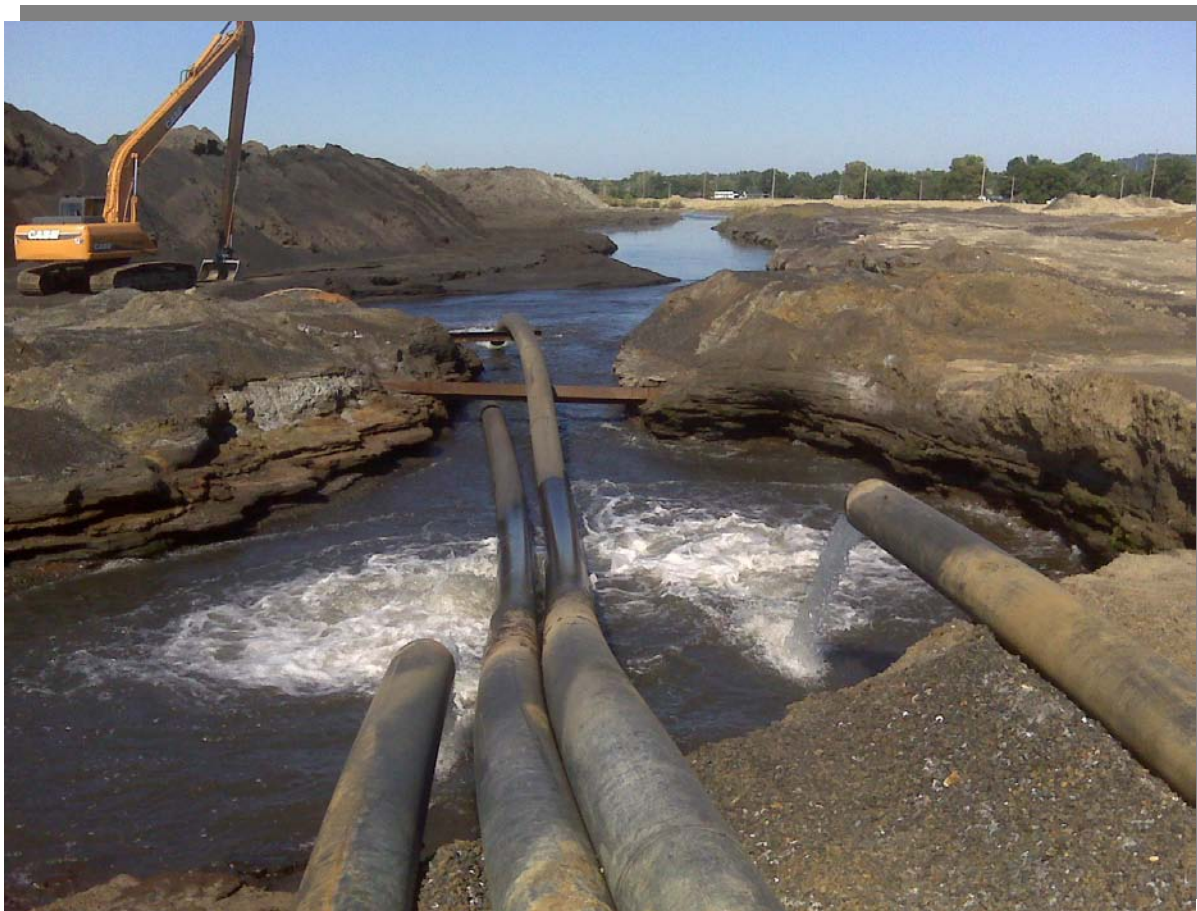
Photo 5 – View of influent pipes discharging into channel cut into ash deposits.

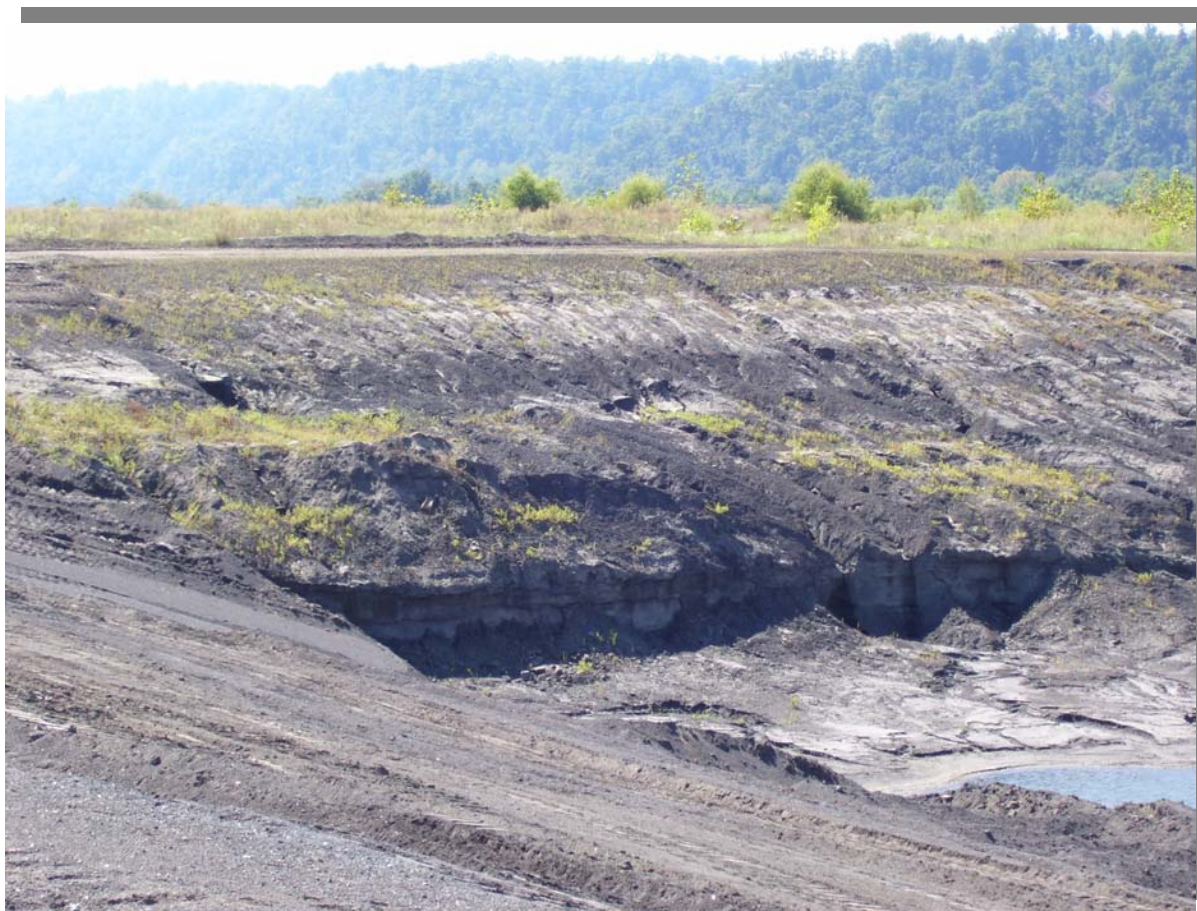
- Although no significant seepage was noted through the interior ash berm, the outboard slope of the berm had experienced significant erosion. Plant personnel indicated that the interior ash berm was temporary and plans were in place to breach the berm in a controlled manner and allow the dredged cell to refill with water and CCW.

Photo 6 – View of interior ash divider dike looking southwest. Note erosion of exposed outboard slope.

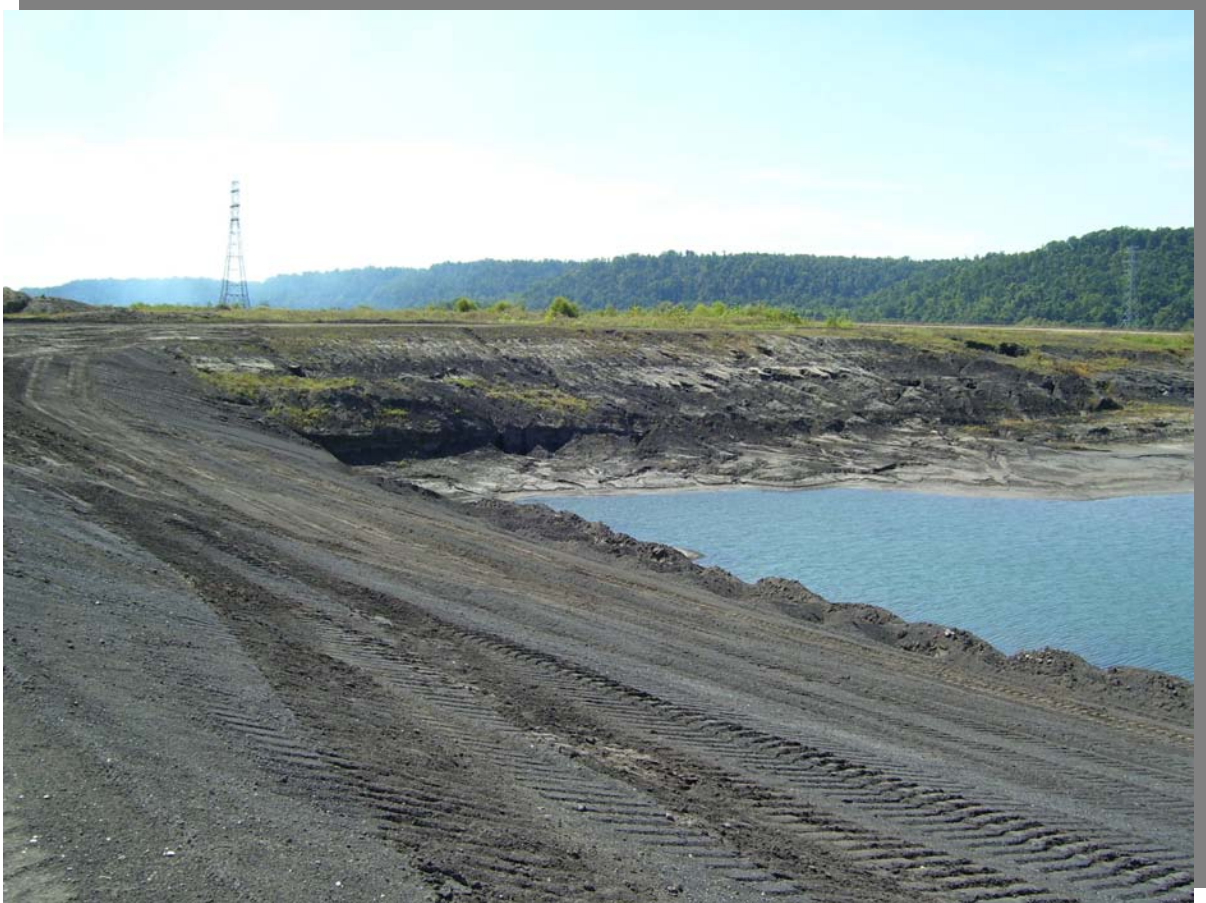
Photo 7 – View of regraded eastern inboard slope, north of divider dike.

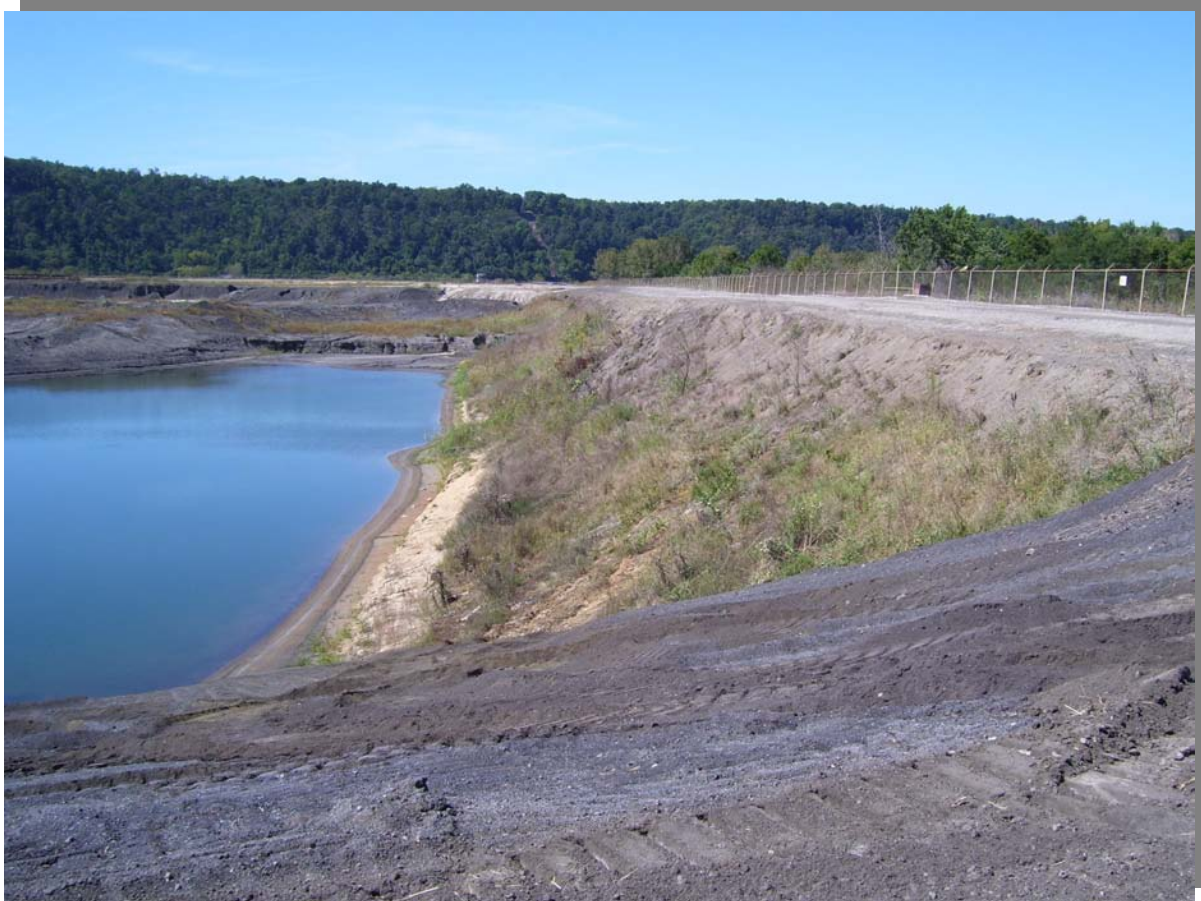
- The crest, gravel crest road, and the inboard exposed portions of the inboard slope appeared to be in good condition; except that the inboard slope of the north embankment exposed by the recent dredging evidenced some erosion (Photo 8).

Photo 8 – View of recently excavated and dewatered cell at north end of the pond. Note steepness and erosion of inboard northern slope.

1. Inboard slopes – repair eroded inboard slope of northern embankment prior to filling. Repairs should be completed in accordance with an engineered design. Inspect and maintain erosion that may develop on exposed portions of all inboard slopes on a regular basis.
2. Outboard slopes – remove trees and mow vegetation at least twice annually. Perform follow-up inspection of north and west outboard slopes after vegetation is mowed to check for adverse conditions such as sloughs, erosion, and seepage. Trap burrowing rodents and fill animal burrows.
3. Divider Dike – maintain outboard slope of divider dike by routinely repairing erosion rills. Monitor for seepage, which could lead to uncontrolled breach.

Erosion repair and flattening of the north inboard slope should be completed prior to filling this recently excavated and dewatered portion of the pond. Based on our conversations with LG&E personnel, it is anticipated that the refilling of this area will be completed before the end of 2009 or shortly thereafter. The owner should continue toward this schedule as planned.

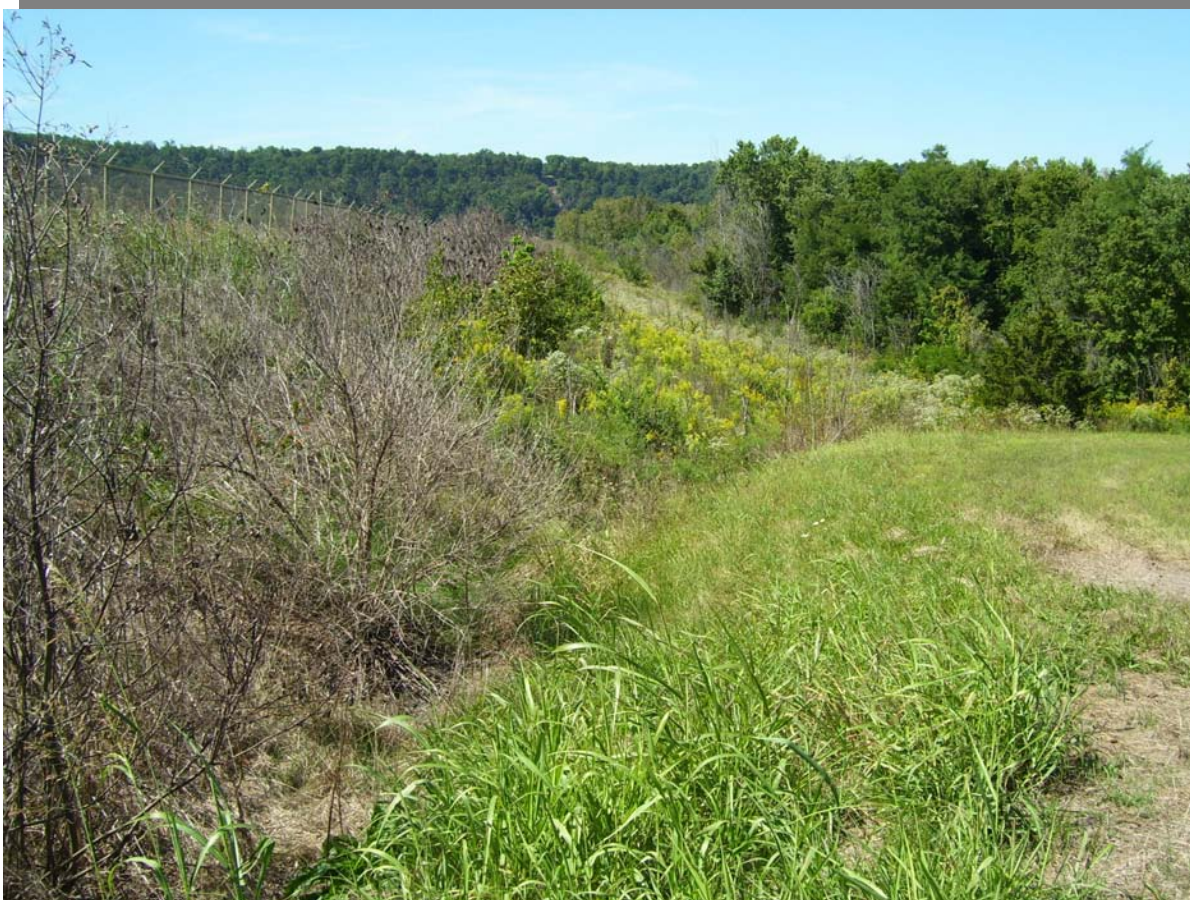
- The outboard slopes of the north and west dikes were heavily overgrown with dense weeds and brush. As such, close inspection of the outboard slope was not possible. Some small trees were also observed. Recent attempts to kill the trees by spraying appeared to have been somewhat effective (Photos 9 and 11).

Photo 9 – View of heavily vegetated northern outboard slope.

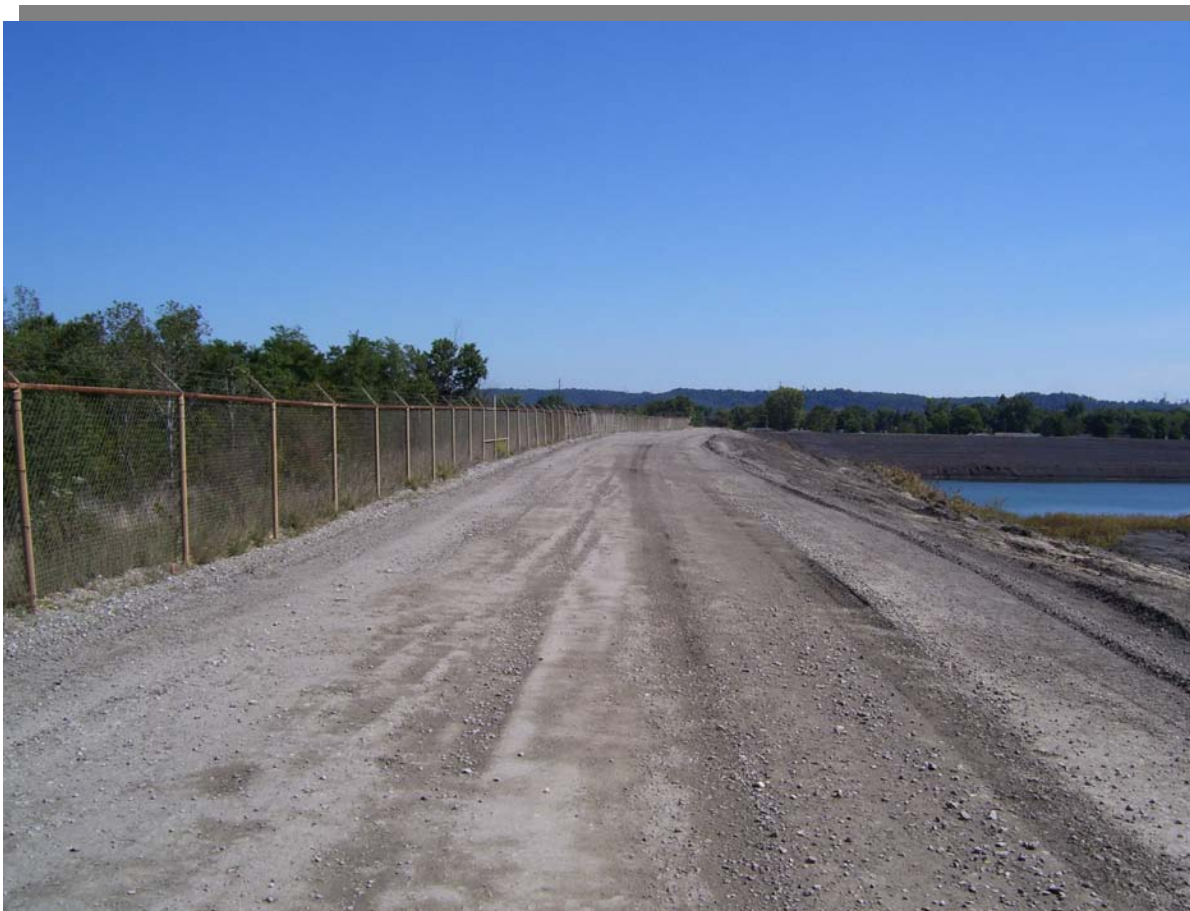
Photo 10 – View along crest of north dike looking east.

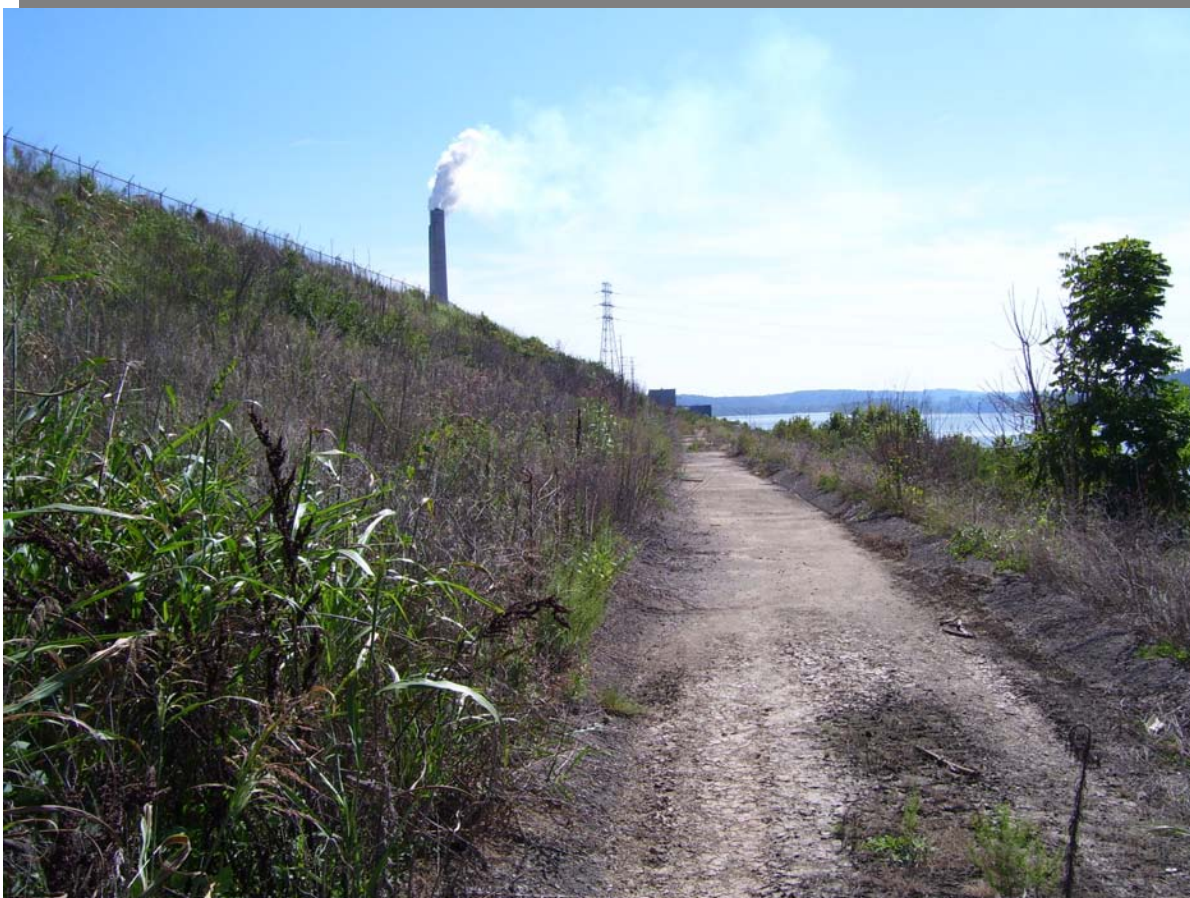
Photo 11 – View of western outboard slope along mid-slope bench road looking south. Note heavy vegetation on the slope.

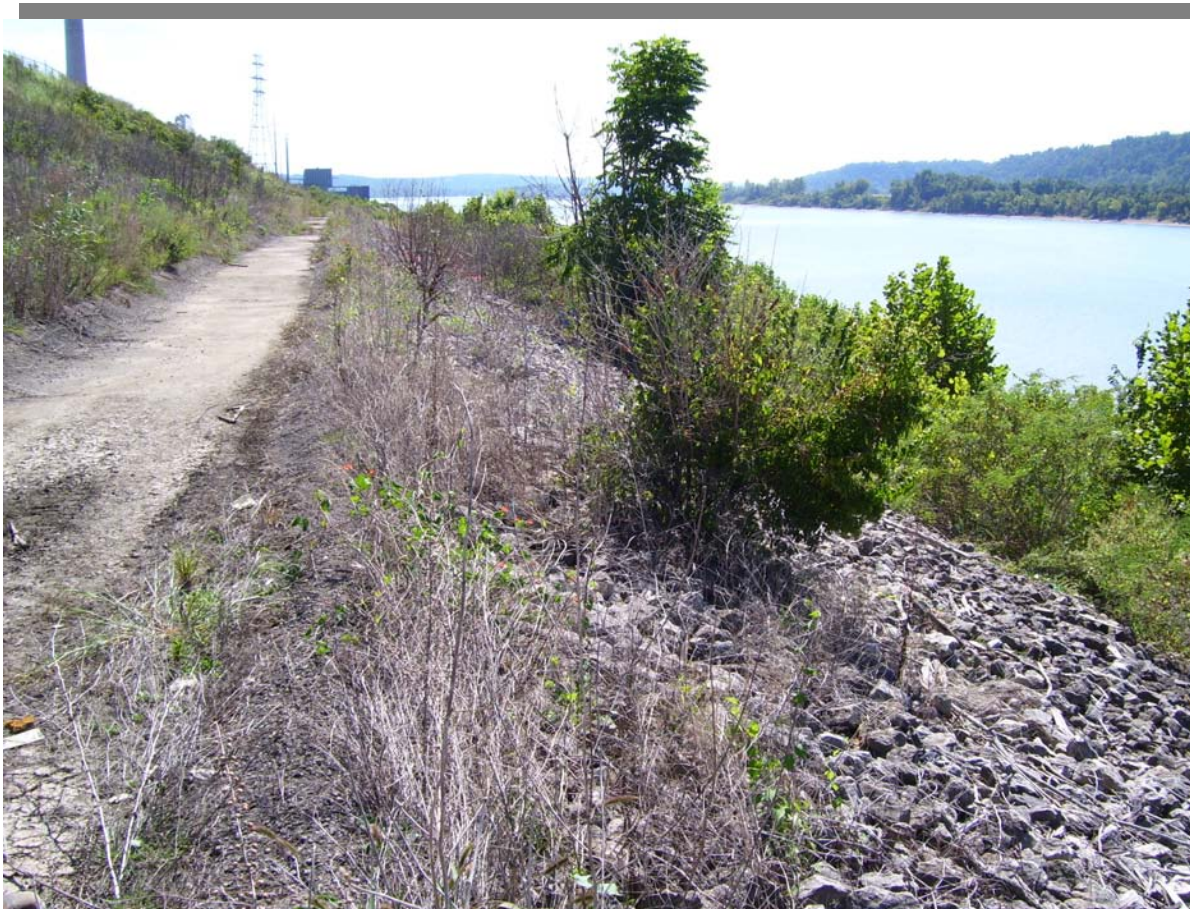
Photo 12 – Riprap armoring of natural slope below western embankment of ash pond.

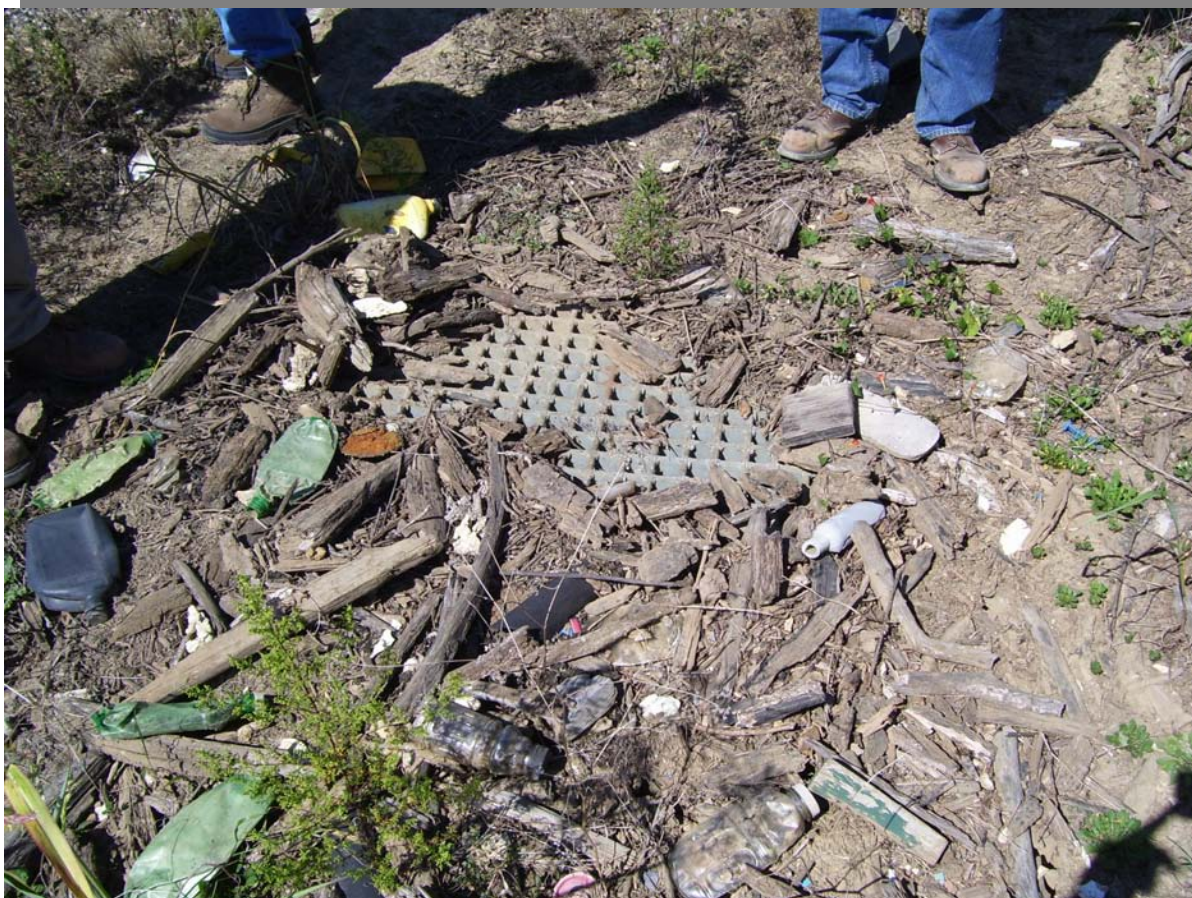
Photo 13 – Grated drop inlet storm drain along western outboard slope bench road.

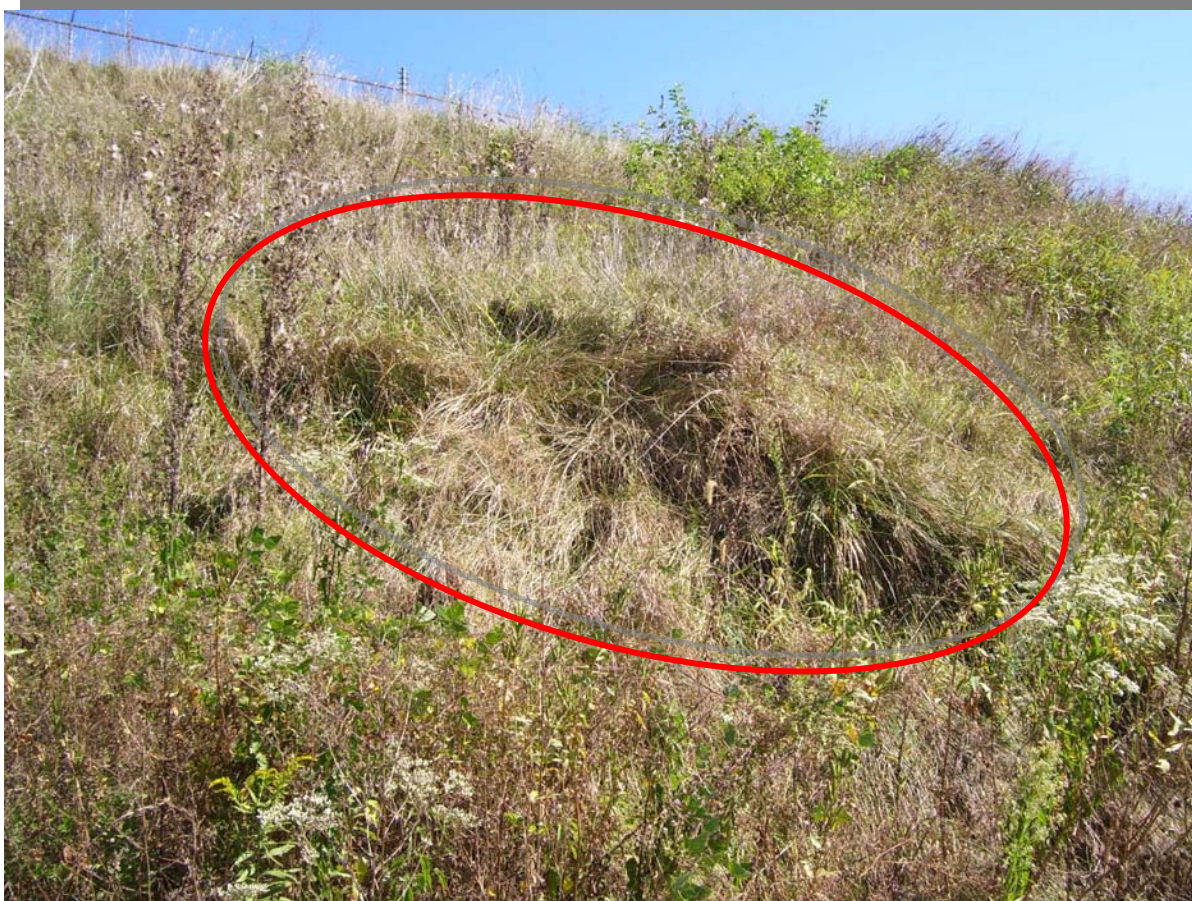
- Several animal burrows were noted on the outboard slopes of the north and west dikes.
- An old slough was noted adjacent to the north side of the Closure Section slope repair area on the west outboard slope. The slough exhibited some minor displacement of surface soils, and appeared to have occurred some time ago (Photo 14).

Photo 14 – Apparent old slough of surficial soils on western outboard slope.

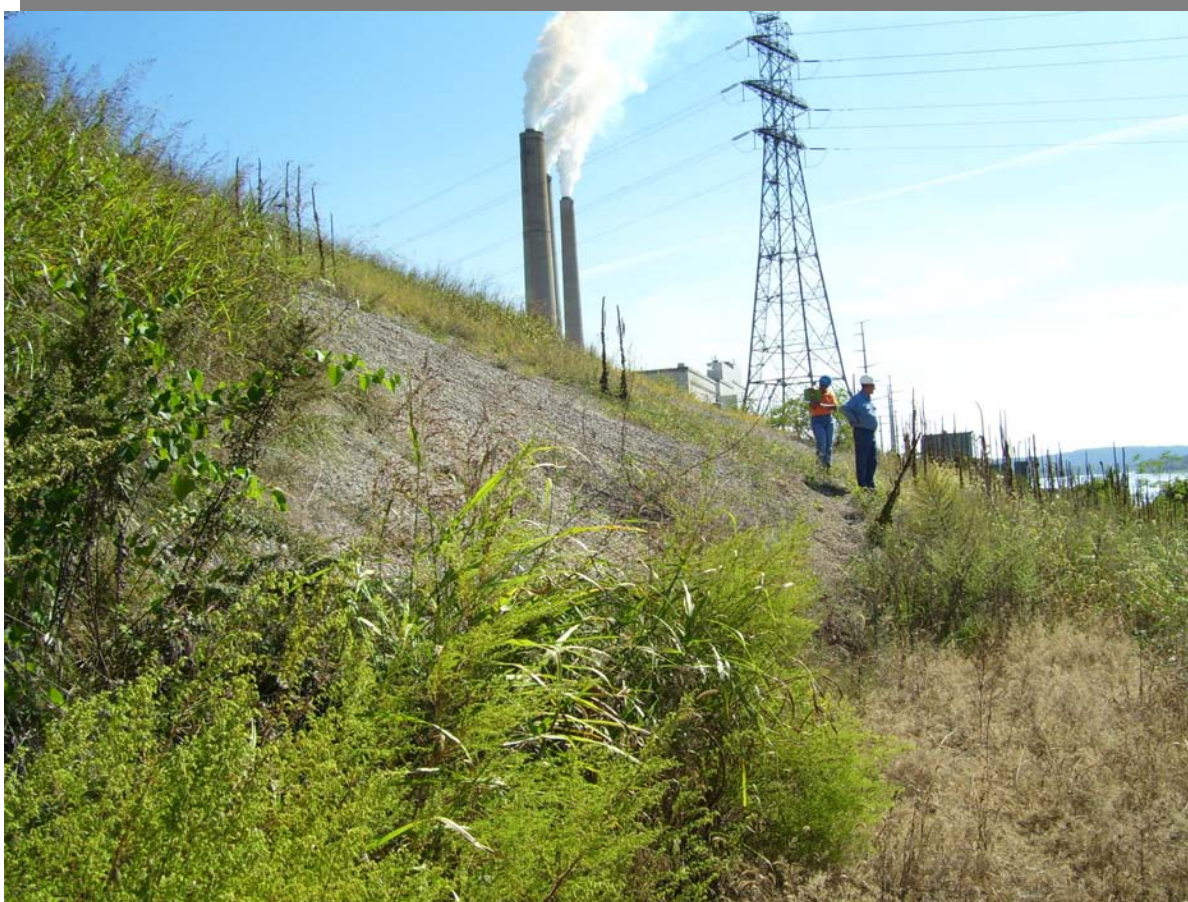
- In 1981, a portion of the Closure Section of the west dike experienced a slide. This slide was attributed to trapped water within granular layers in the embankment soils, which were capped with clayey soils on the slope face. Remedial measures involved removal of the failed soils, flattening the slope to 2.5H:1V, and construction of a gravel drain on the slope face to alleviate trapped water within the embankment.

Photo 15 – Gravel blanket drain/slope failure repair area on western outboard slope.

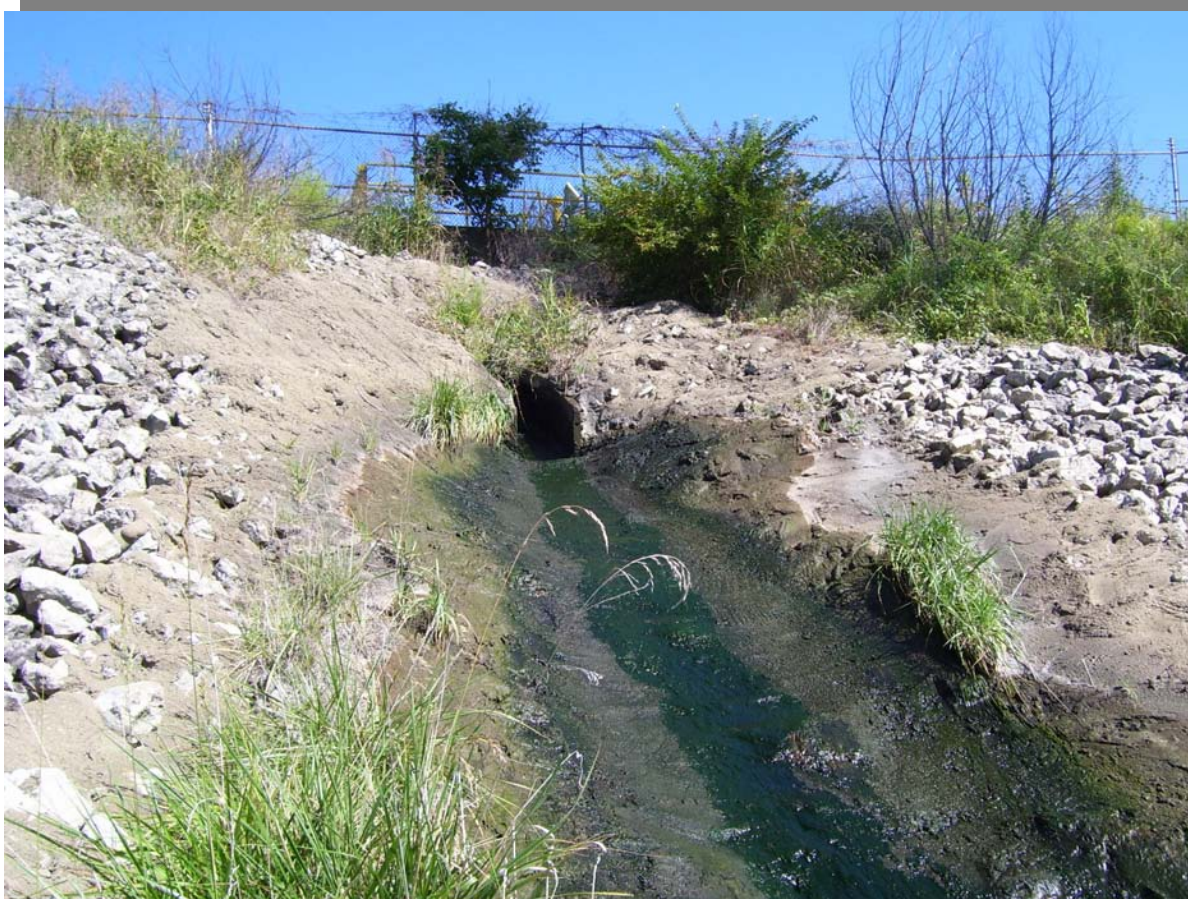
- No seepage or wet areas were observed on the outboard slopes or at the outboard toe, where accessible.
- The outlet structure appeared to be in good condition and functioning normally. Associated trash racks, weirs, the grouted-riprap channel and concrete flume all appeared in good condition (Photos 16 and 18).

Photo 16 – Outlet flume and grouted riprap outlet channel looking upstream.

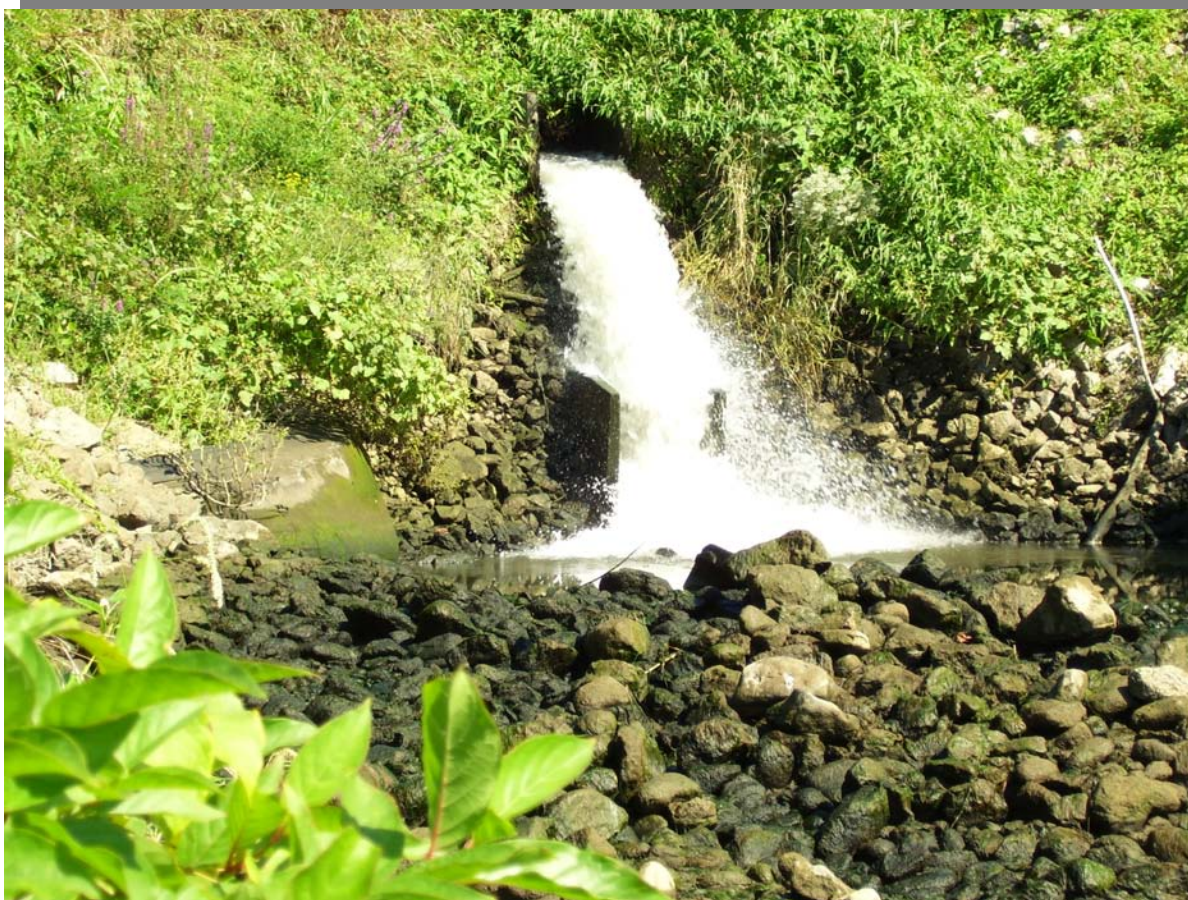
Photo 17 – Outfall of Ash Pond discharge into Ohio River.

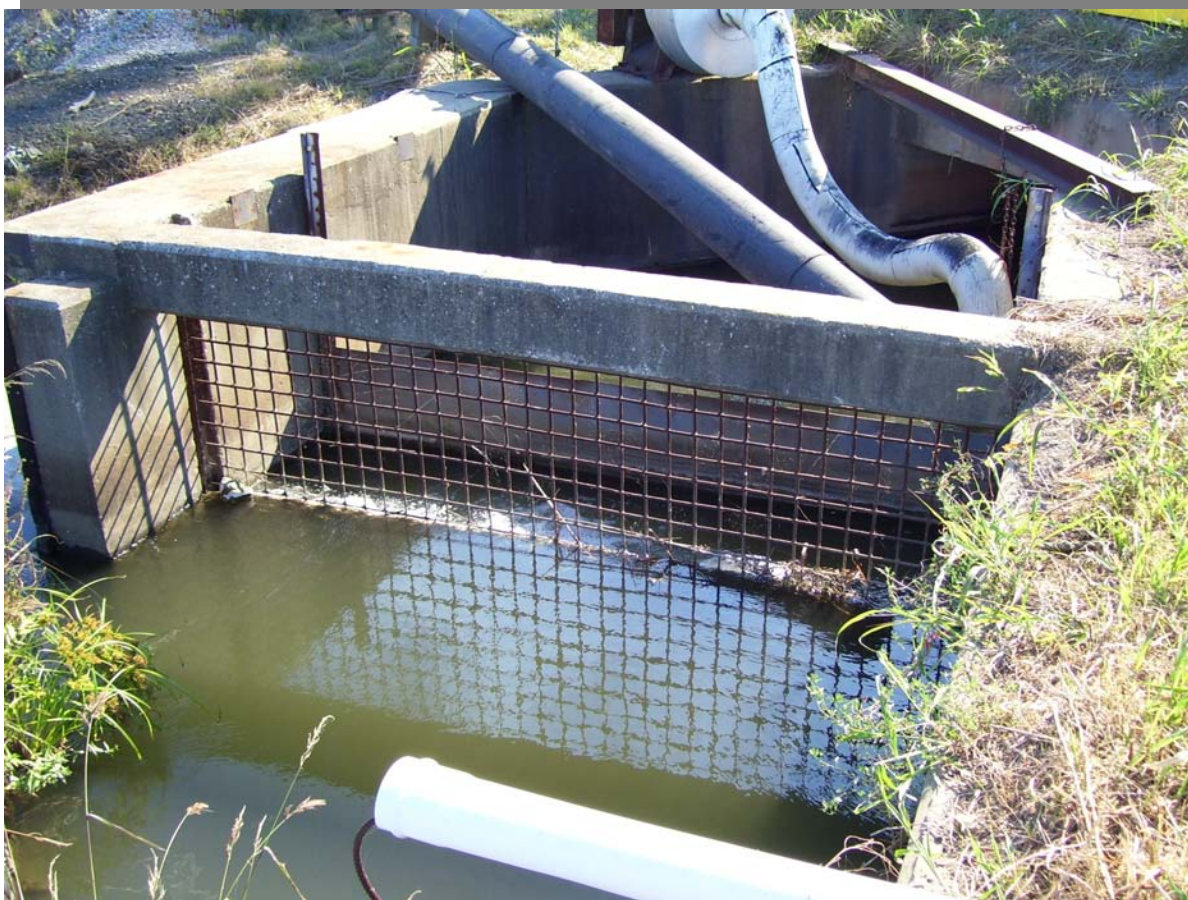
Photo 18 – View of Ash Pond outlet structure looking downstream.
